IRATA Safety Notice

IRATA Work and Safety Report 08/01

Summary of incidents reported on Form 021 2006/2007

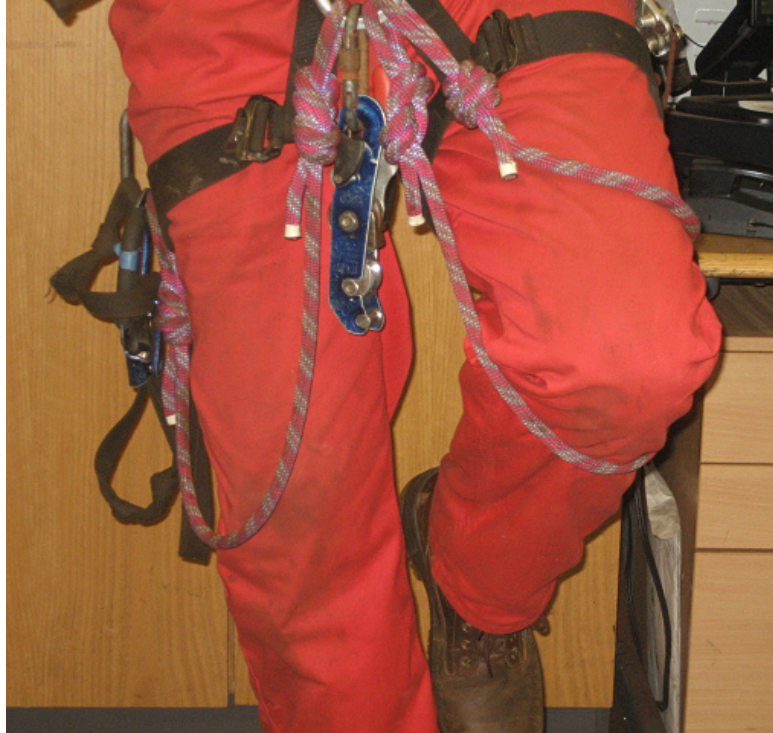
Incident where a cow's tail caught round a technician's knee as he stood up.

The photo illustrates a not unusual occurrence, which is usually without serious consequences. However this turned into a lost time incident, as it was necessary for the technician to be evacuated with a back strain.

Trainers are advised to emphasise suitable stowage of cow's tails and foot loops when not in use to prevent this happening. There are a variety of ways to do this by tucking them into leg loops or shortening them. Level 3s and buddy checking of each other should encourage this safe practice.

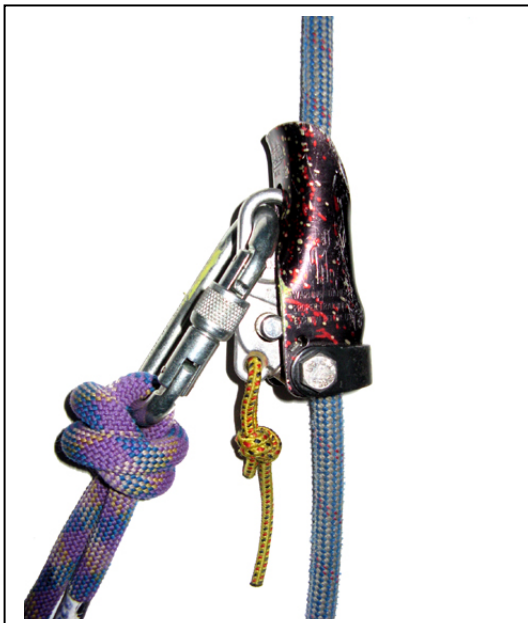
Photo 2
Shunt retained by karabiner to prevent dropping.

Warning: This is dangerous if accidentally loaded in this way.

Petzl Shunt: Before removing the shunt from the rope, remove the karabiner and carefully push the cam through the body to other side of the rope and replace the karabiner through the cam. [See photo 2]

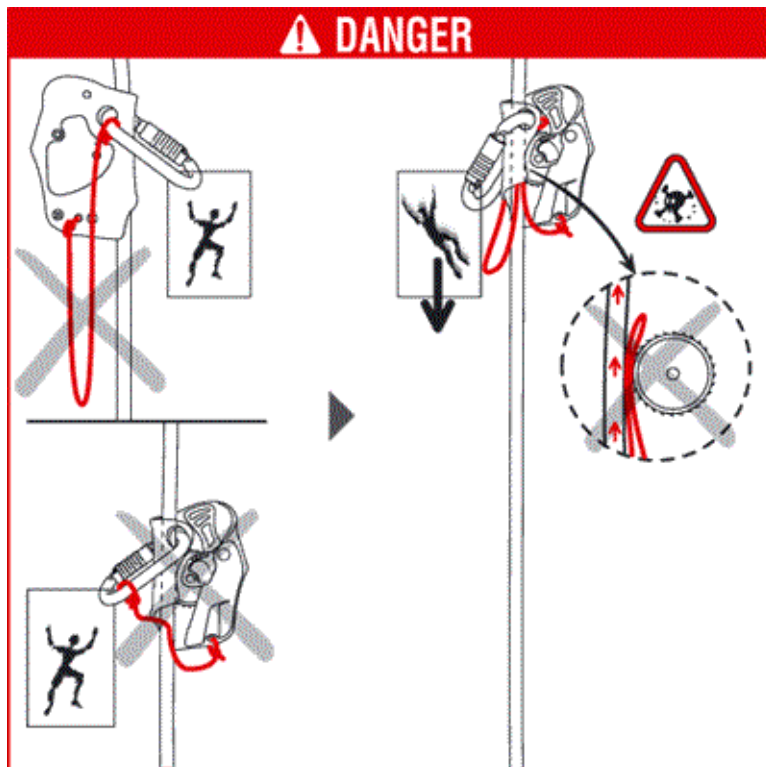
Fig. 2

Warning danger (fig. 2)

There's a risk that the keeper cord may get jammed in the toothed wheel, causing the ASAP to malfunction.

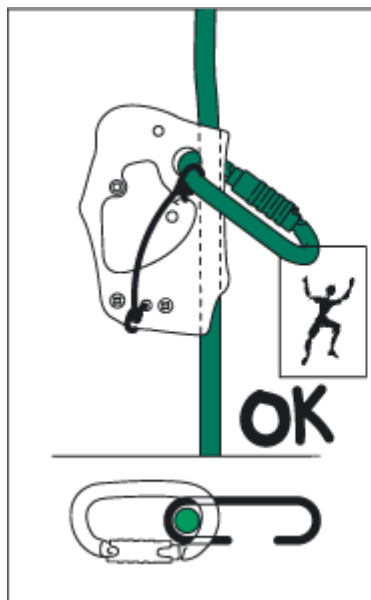
Fig. 3

WARNING: when using the ASAP, the OK TRIACT karabiner must be clipped through the 2 attachment holes and the rope must run inside the karabiner. IF NOT, DANGER OF DEATH (fig. 3).

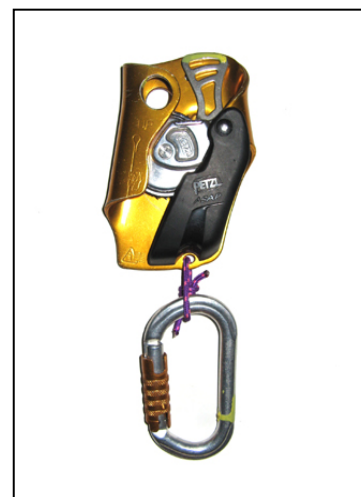
Photo
3

Photo 3: Shows an alternative where the lanyard karabiner is placed in a small loop of cord in the lower hole to prevent dropping the ASAP as it is removed. Warning: this is obviously dangerous if the ASAP is loaded by this karabiner from this loop.

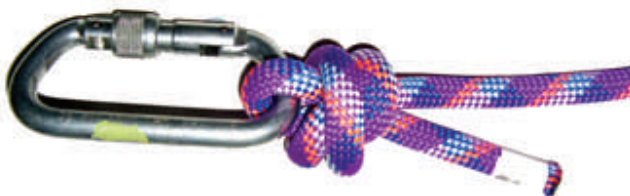
Figure 7

This dangerous knot is a tightened version of Figs 4 - 6 and looks very like Fig 3 at first sight.

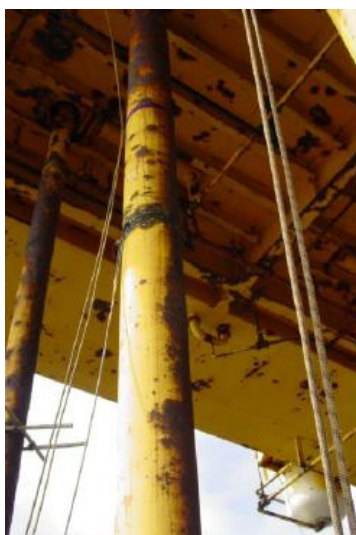
Figure 1 - Area in which rope access hot work was taking place

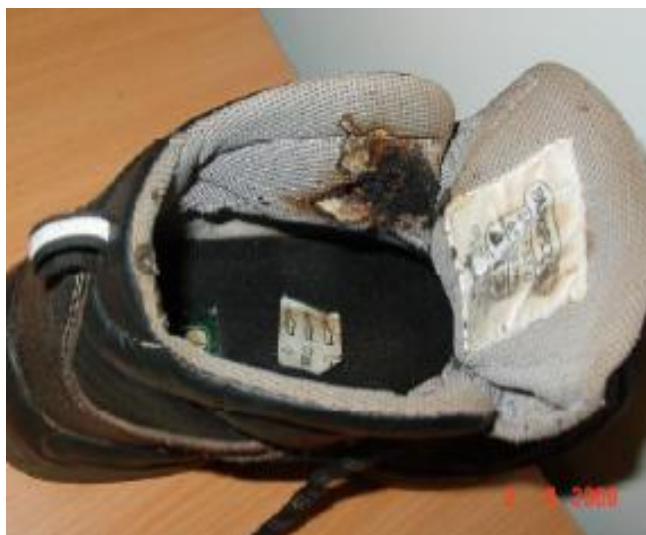
Figure 2 – Injured person's safety shoe showing burn damage

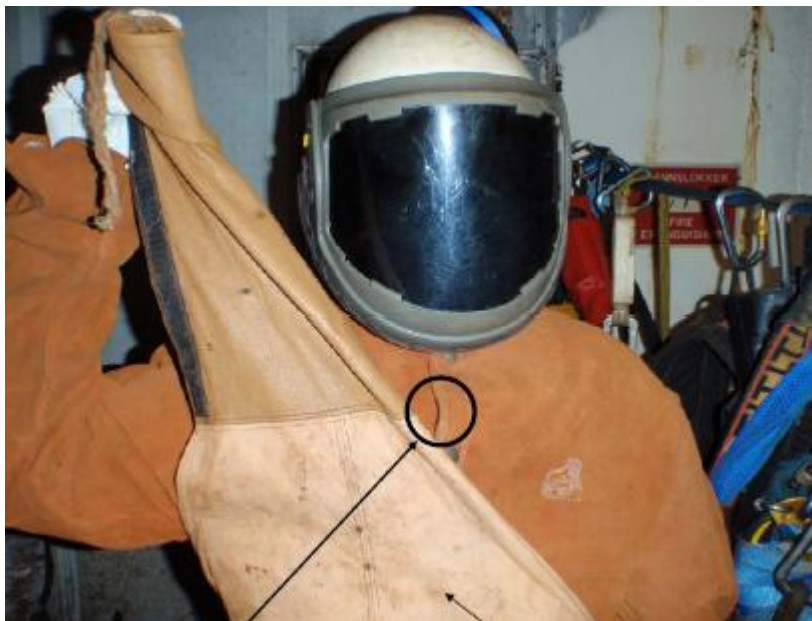
Figure 1- Protective clothing for rope access technicians showing small opening through which hot particle passed

- ◆ Protective jackets used for hot work should close using "velcro" closing straps rather than buttons;
- ◆ Consideration should be given to different kinds of protective clothing, including flexible fireproof hoods designed to cover shoulder, chest and neck area;
- ◆ It should be emphasised at toolbox talks and in preparation for hot work that molten particles can enter PPE through the smallest openings.

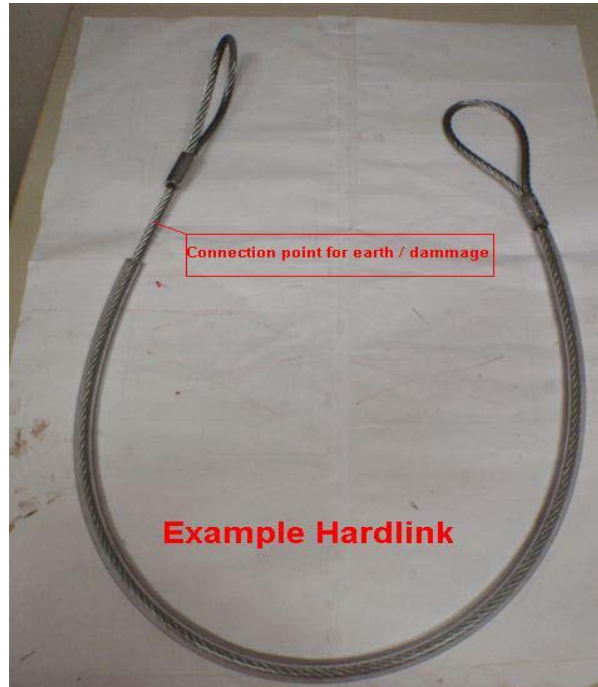
Figure 1 - Typical metal 'hard-link' for rope access technicians

- ◆ Replace metal hard-link with a non-conductive nylon climber's sling;
- ◆ Ensure water is drained out of air supply before use with gouging torch.

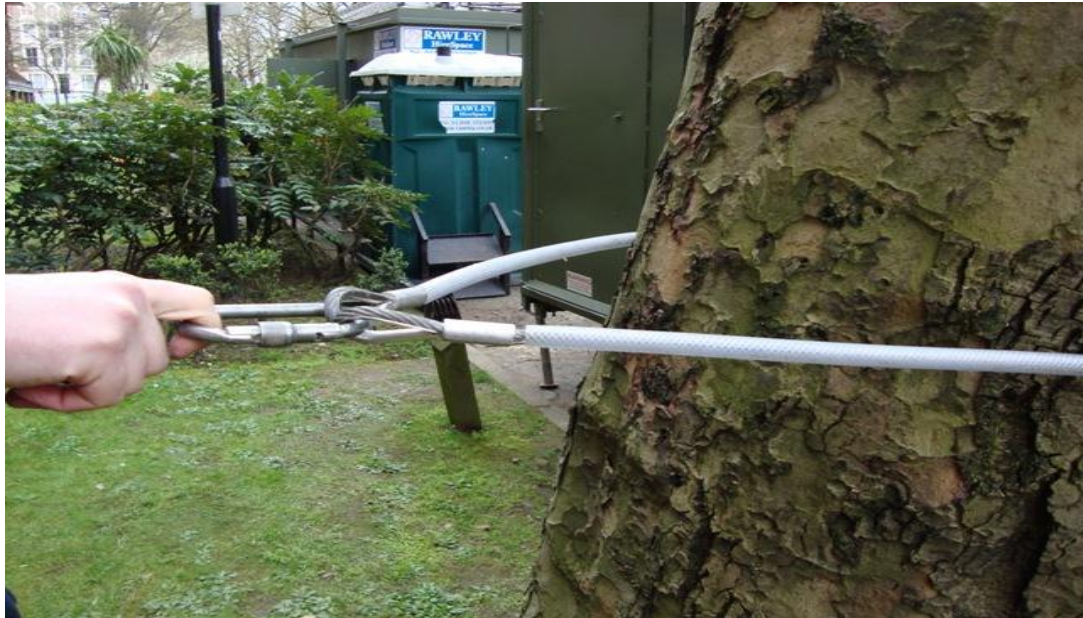
Photo 1: Strop set up as a Primary Anchor. There were four of these together to anchor four ropes.

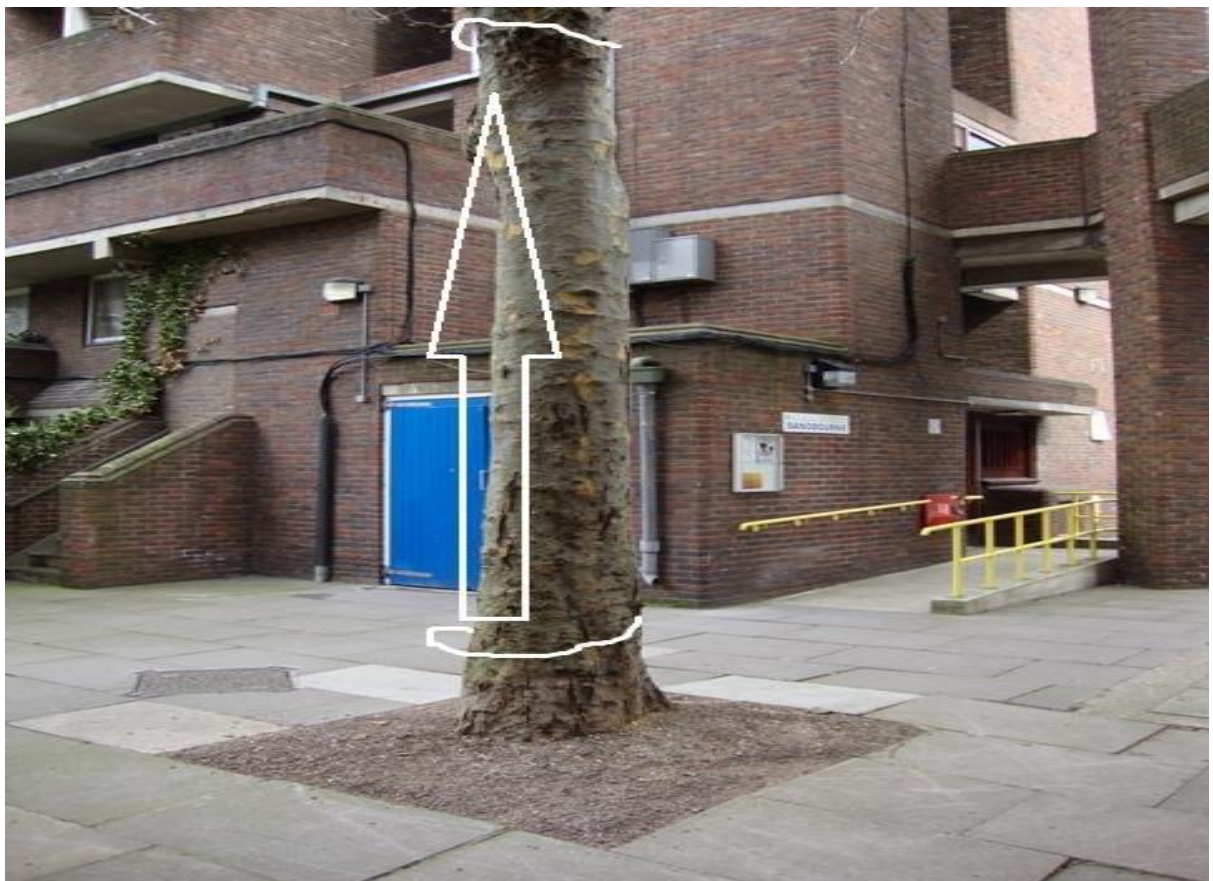
Photo 2: Indicating (approximately) where the ropes where originally rigged (at low level) and where they eventually came to a stop.

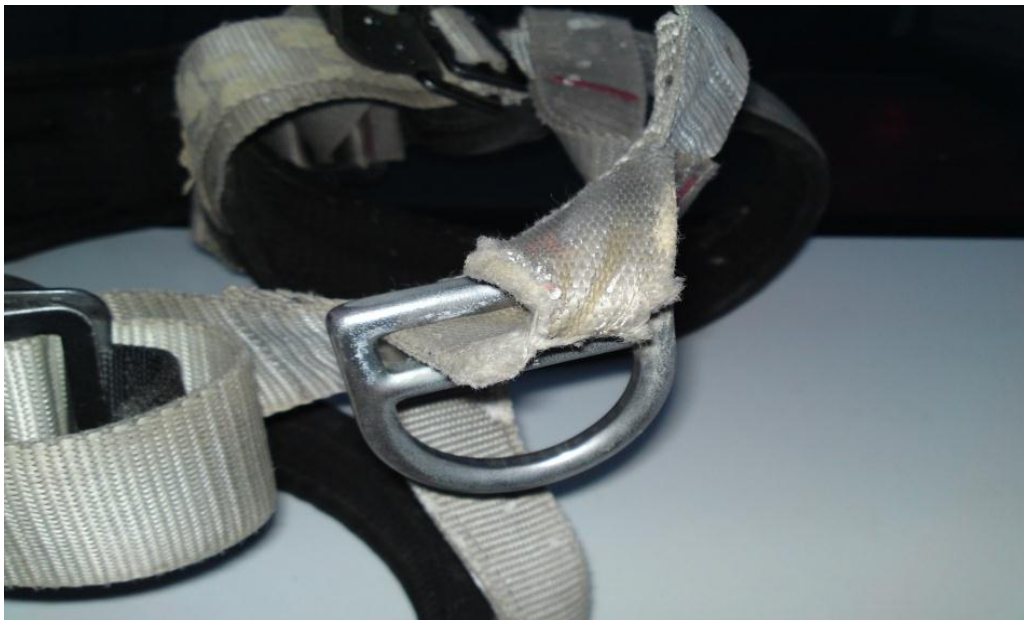
- 4 Excessive wear on the harness webbing attaching the D-ring.
Action: Pay attention to areas of high wear. Be aware that damage which builds up slowly may not be as obvious.

Excessive wear on webbing loop of a sit harness

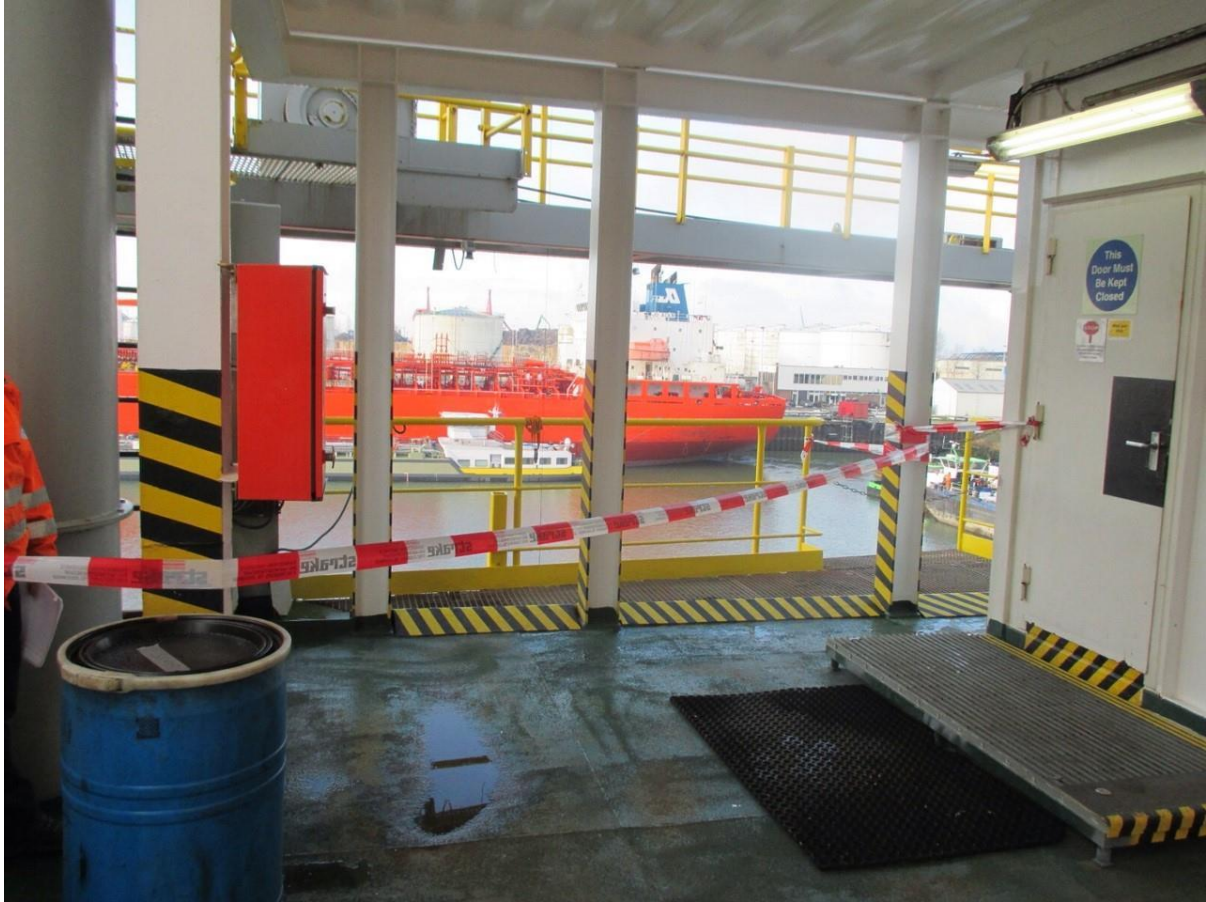
The use of barrier tape to prevent third party access was totally inadequate bearing in mind the removal of walkway grating and creating an exposed edge. This may have contributed to the overall

Figure 2 - Working space barricaded with red/white barrier tape
