IRATA Safety Notice

IRATA Work and Safety Report 08/01

Summary of incidents reported on Form 021 2006/2007

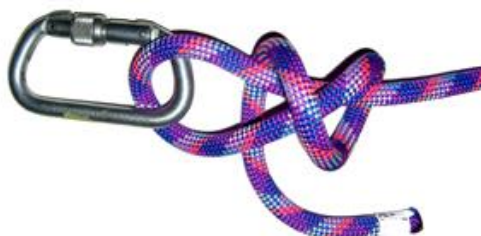
Figure 1 -

This is tied by passing approximately 50cm of the tail end of the rope over the karabiner and tying half a double fisherman's knot around the section going back to the harness.

In a pre-use check, the knot should be adjusted for length and loaded; the tail should also be tightened. If the knot is not adequately tightened the wraps may work loose and come undone. It is good practice to unfasten and re-tie cow's tail knots periodically to avoid them becoming over tightened.

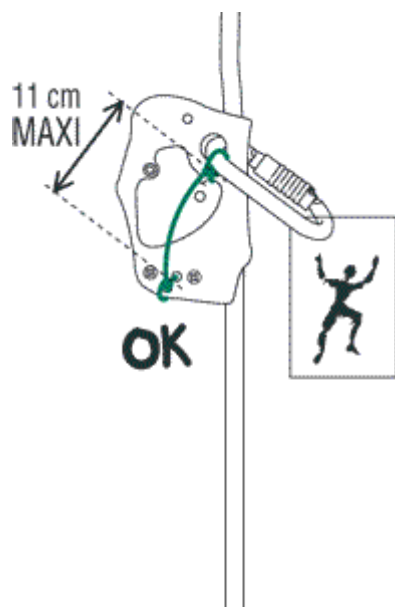
Fig. 1

Tie one end of the keeper cord to the lower hole of the ASAP (identified as #7 in the *Nomenclature* section of the Instructions for Use). The knot of the keeper cord must be tied as close as possible to the device to keep the size of the loop to a minimum. Make a loop at the other end of the cord and connect it to the OK TRIACT karabiner. The loop must be tightened on the body of karabiner so that it stays in place close to the ASAP attachment holes. The cord must be short: once in place, it should be no longer than 11 cm. It's possible to use an elastic cord to make handling easier, as long as it's no longer than 11 cm when it's not stretched. When attaching the ASAP to the rope, run the keeper cord along the backside of the device (the side opposite the toothed wheel). Once the OK TRIACT karabiner is connected to the ASAP, the keeper cord must not be able to reach the toothed wheel.

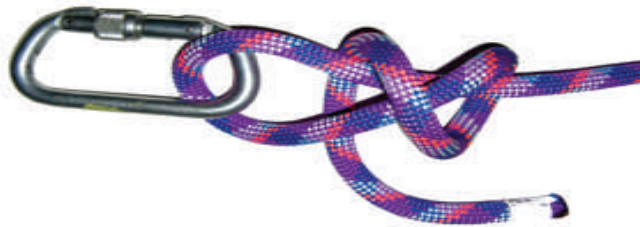
Figure 1

This is tied by passing approximately 50cm of the tail end of the rope over the karabiner and tying half a double fisherman's knot around the section going back to the harness.

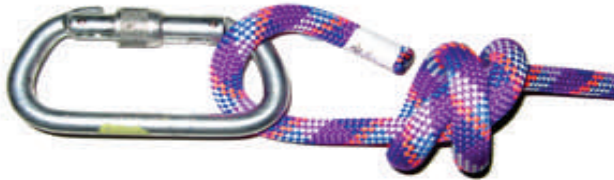
Figure 5 - Method 1

The tail is passed over the karabiner and pushed back through the body of the knot to give the result in Fig 7 when tightened.

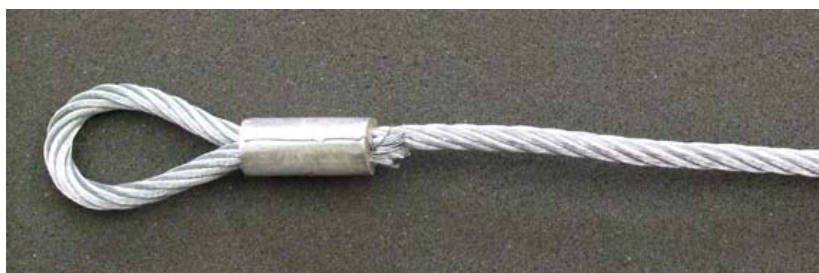
A member working on an oil platform issued a non conformity / improvement opportunity report, after it was noticed that sparks had come from a galvanised wire anchor sling. Since the possibility of causing a spark is obviously to be avoided in any potentially explosive atmosphere the work was stopped. In a safe area, the sparking was replicated by rubbing the wires on a piece of rusty steel.

The possible cause of sparking is too complex to explain in this safety bulletin, but the following precautionary action is recommended.

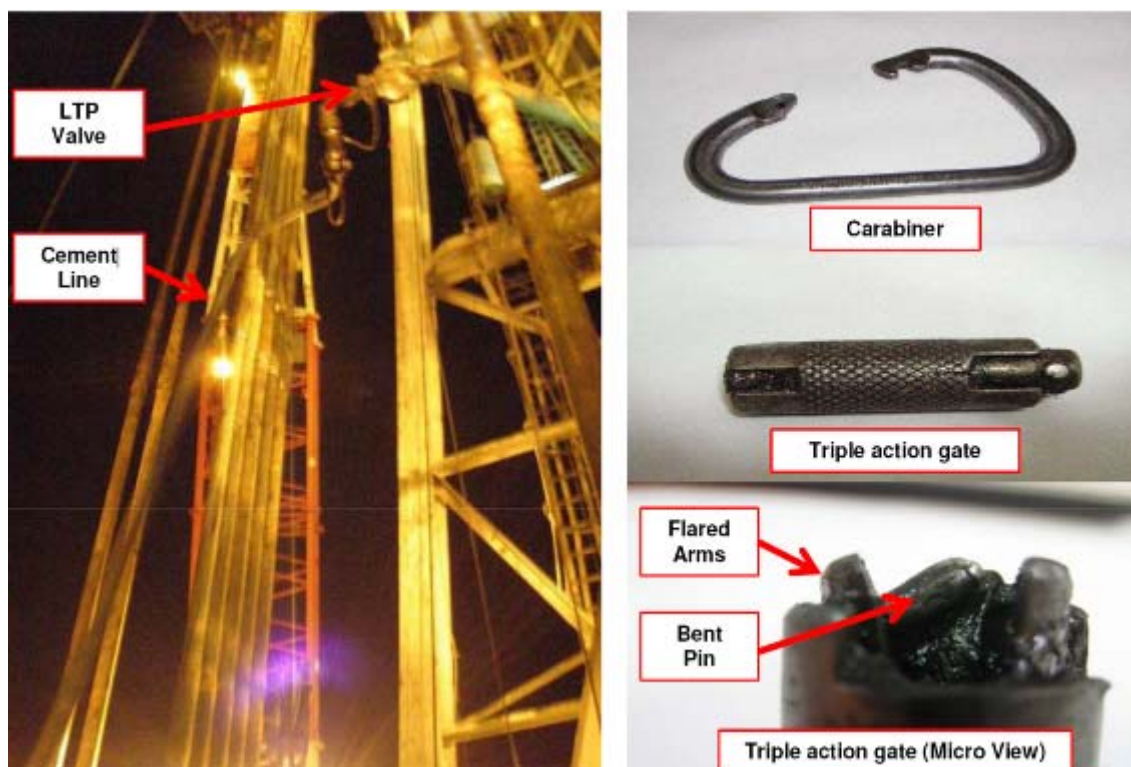
Manriding Incident – Carabiner Failure

Operation of the valve involved some physical movement of the man in the riding harness. The man-rider then pushed away from the valve, grasped a cement hose with his right arm and signalled to the tugger operator to commence lowering. As lowering began, the carabiner locking gate broke free from the carabiner body. The man-rider became disengaged from the tugger wire rope and fell to the rig floor. Because he was holding the cement hose, this action slowed his descent. He landed feet first and rolled to absorb the fall.

Examination of the carabiner was carried out by a Materials and Corrosion Engineer. A considerable amount of dirt was found lodged around the latch pin and between the latch yokes. This contamination may have prevented full gate closure of the carabiner by stopping the gate sleeve from rotating to lock the latch. This would have left the tensioner spring as the only mechanism holding the gate closed.
